Phase I Environmental Site Assessment Report

Former Macon Telegraph Publishing Company & Adjacent Parking Lots

120 Broadway • 139 Broadway
415 Walnut Street • 179 Fifth Street
Macon, Bibb County, Georgia 31201

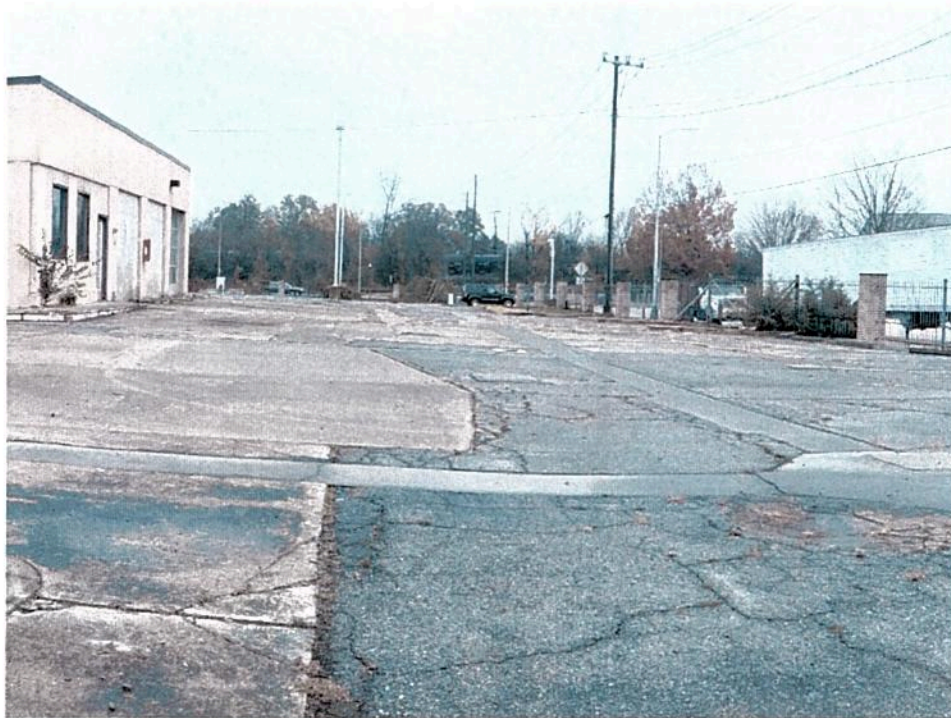
Photograph 1: Looking north toward the former gas station & remediation system artifacts in the Broadway parking lot at Walnut Street.

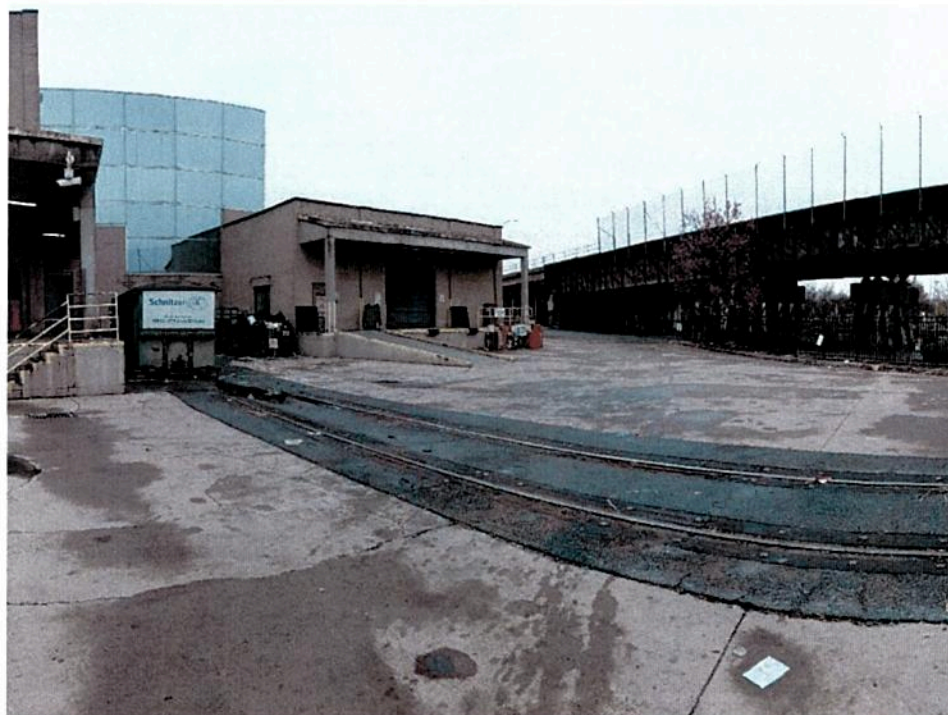
- A single railroad track leading from the eastern edge of the main building to the eastern edge of the parcel boundary corroborated the site's former status as a freight station.

Photograph 2: Looking northwest toward the railroad track leading to the main building.

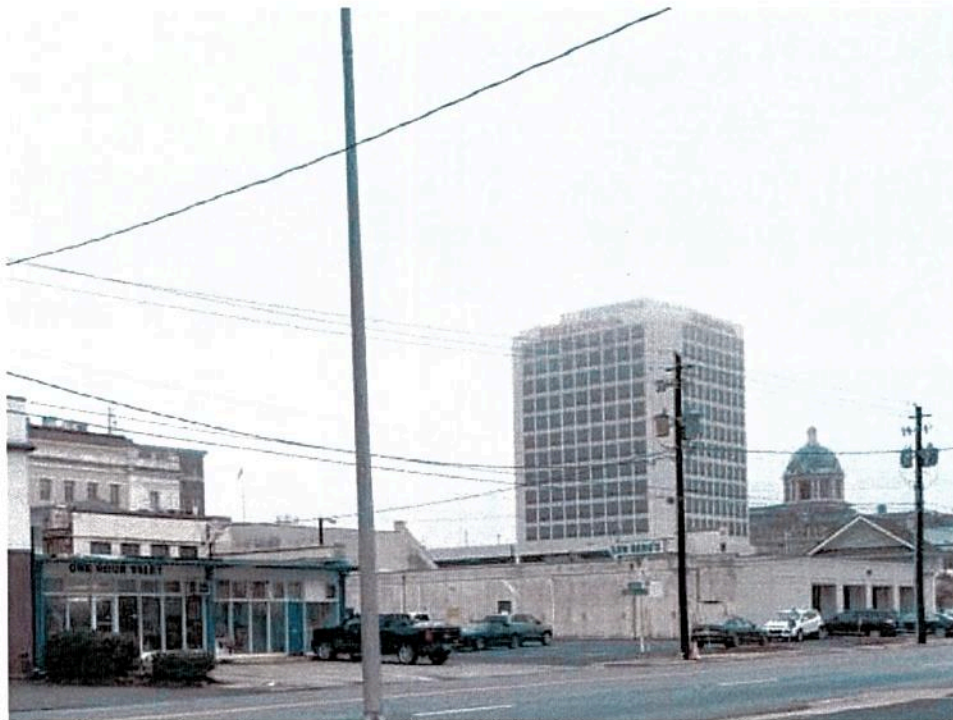
- The nearby presence of One Hour Valet dry cleaners just 90 feet hydraulically upgradient represents another de minimis condition. The proximity of the dry cleaners allows for the potential of vapor encroachment into site structures.

Photograph 3: Looking southeast towards One Hour Valet dry cleaners from the former gas station parking lot

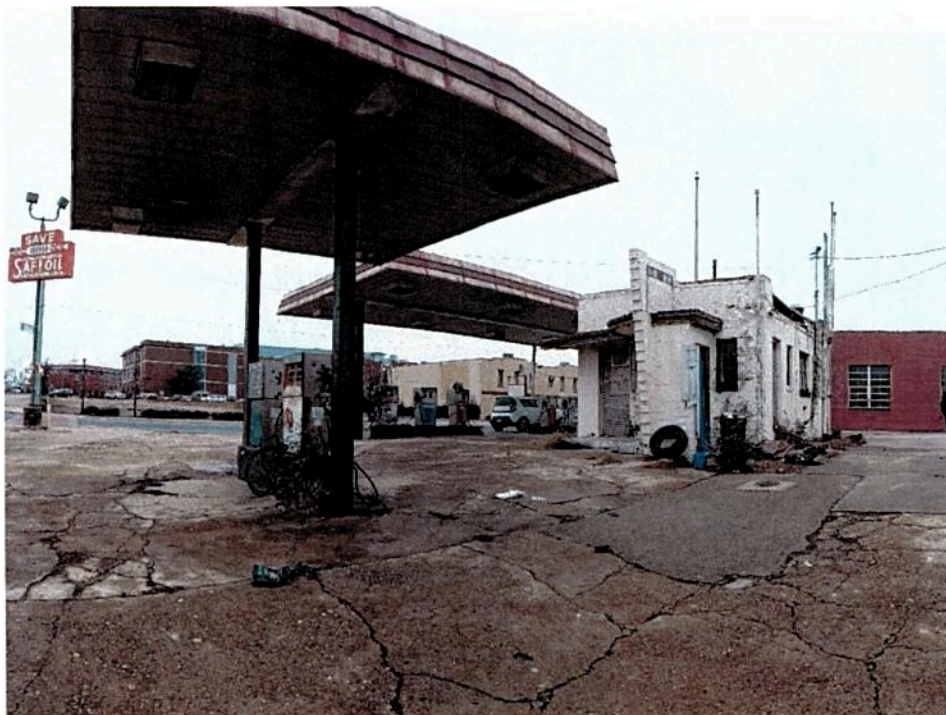
Photograph 4: Looking southwest towards the former Saf-T-Oil filling station from MLK Jr Blvd

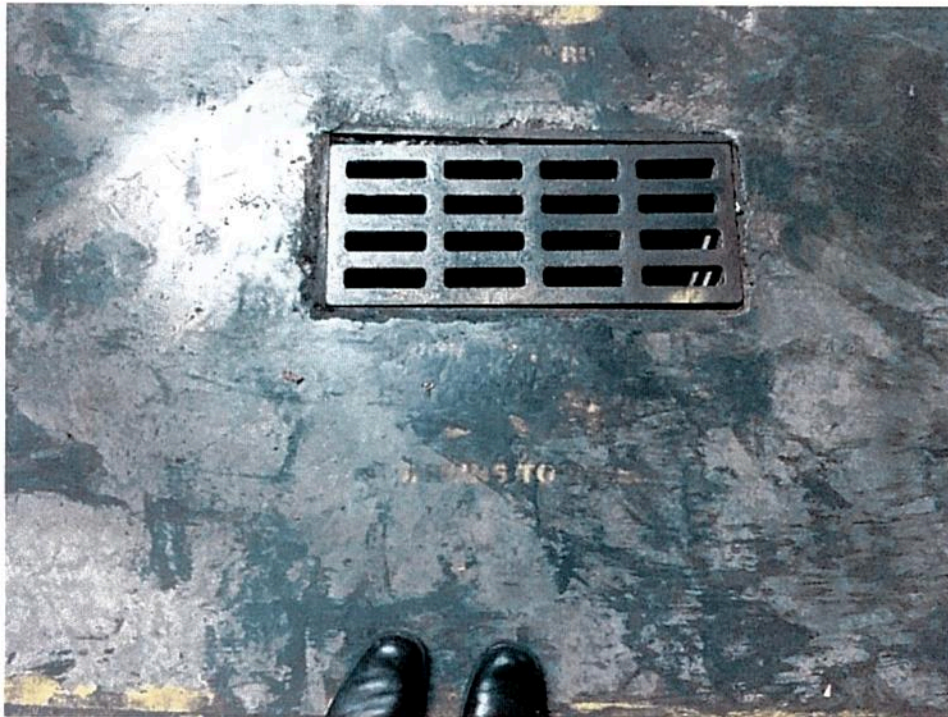
- ***Odors***
 - No unusual odors were noted.
- ***Drains***
 - Several floor drains were visible, most of which are believed to discharge into Macon Water Authority system. Two of the floor drains discovered were identified as sumps: one in the main building subfloor warehouse and one in the main building ink storage room. One floor drain was observed in the bay portion of the former fueling station.

Photograph 5: Looking down at the main building subfloor warehouse sump

- The contents of the standing water in the two sumps in the main building (subfloor warehouse & ink storage room) should be characterized and properly managed.
- Labeled containers/drums should be removed and properly disposed.
- Unlabeled containers/drums should be characterized and properly disposed.
- The black staining & concrete rubble in the pressroom indicative of heavy machinery should be characterized. If floor cracking or a different route of soil exposure is identified after the rubble is removed impacts to site soil and/or groundwater should be evaluated.
- The dielectric fluid in the transformers located in the basement of the main building along the interior of its western wall should be tested for the presence of PCBs & characterized for disposal.
-

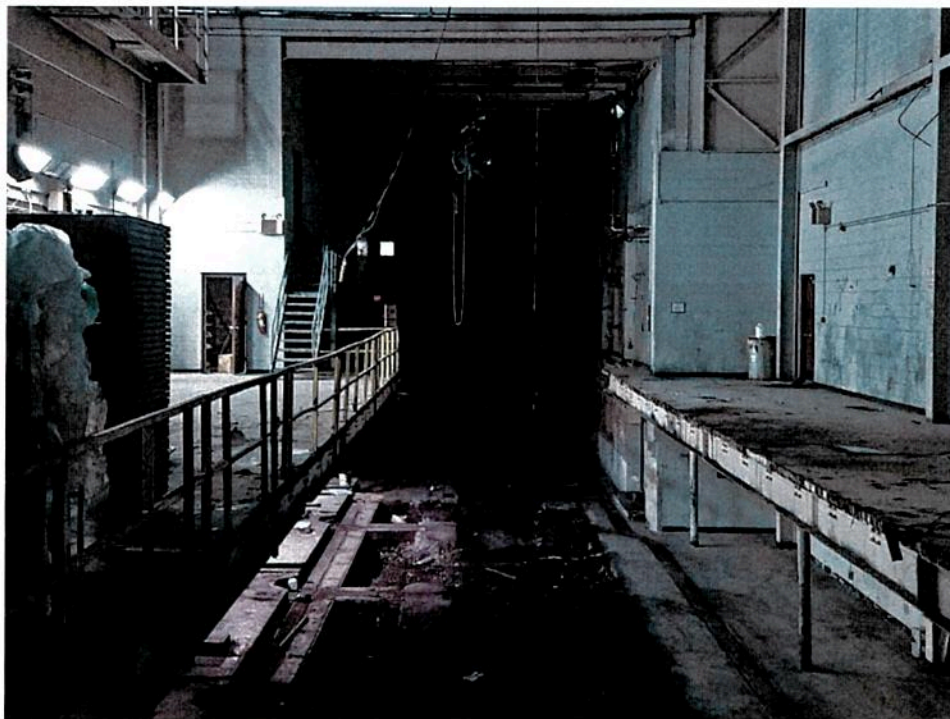
- ***Surface Discoloration***
 - The floor of the former pressroom in the main building showed widespread black staining and concrete rubble in the vicinity of floor drains.

- ***Lead Contamination***
 - No explicit lines of evidence for lead contamination were identified, but the black staining on the floor of the former pressroom in the main building could potentially contain metal residues associated with printing inks.

- Artifacts from the main building’s historical use as a publishing company including sumps, the presence of chemicals associated with newspaper production, and black staining & concrete rubble in the pressroom constitute an additional REC.

Photograph 6: Looking northwest into the former pressroom. Note black staining on concrete rubble on floor.

- Labeled containers/drums should be removed and properly disposed.
- Unlabeled containers/drums should be characterized and properly disposed.
- The black staining & concrete rubble in the pressroom indicative of heavy machinery should be characterized. If floor cracking or a different route of soil exposure is identified after the rubble is removed impacts to site soil and/or groundwater should be evaluated.

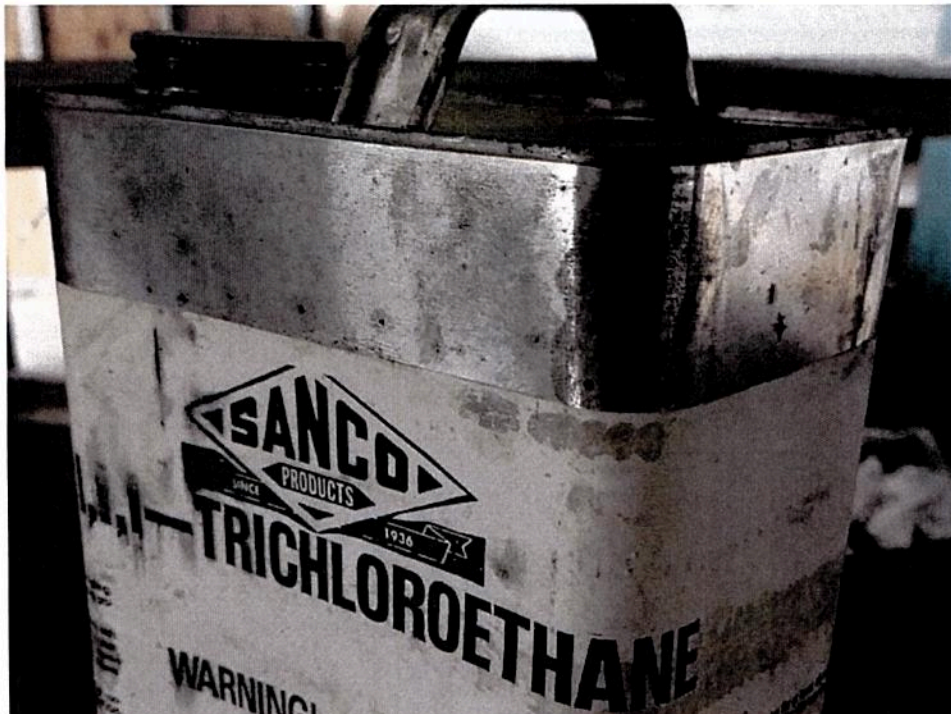
- Several labeled 55-gallon drums and other smaller containers were observed within the main building, generally around the former pressroom. Instances include multiple 55-gallon drums of photographic fixing concentrate, a relatively small (less than 5-liter) metal container of 1,1,1-trichloroethane, and miscellaneous containers of various proprietary solutions associated with printing operations.
- Several small (less than 5-liter) chemical containers were observed within the former fueling station. Instances include motor oil, weed killer, and paint.

Photograph 7: A relatively small (< 5-liter) metal container of 1,1,1-TCA found in the former business card printing room in the main building basement

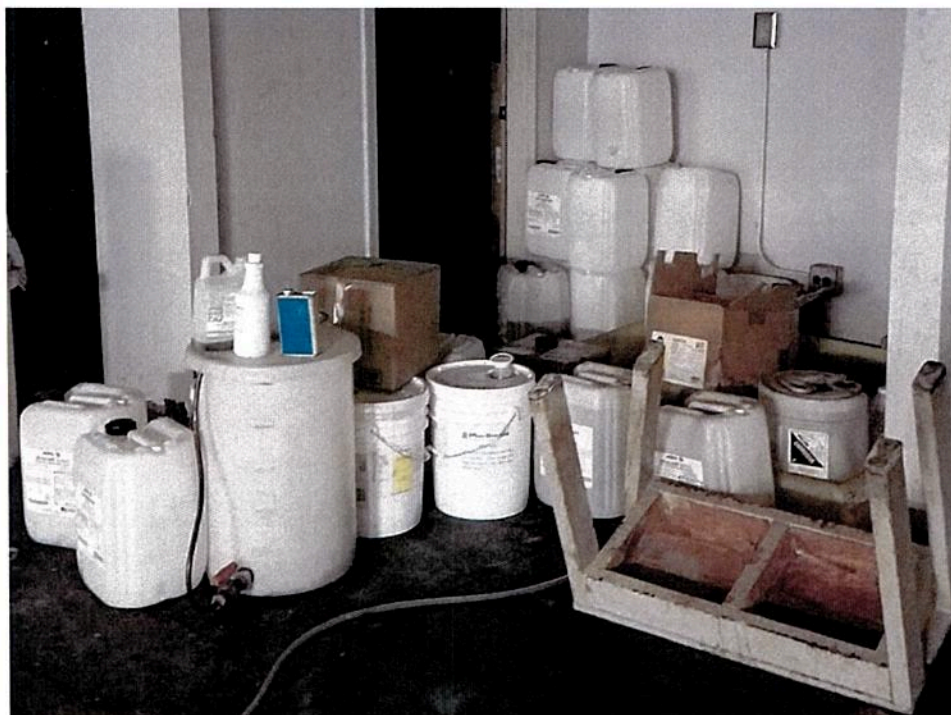
Photograph 8: A representation of the various chemical containers found in the basement of the main building

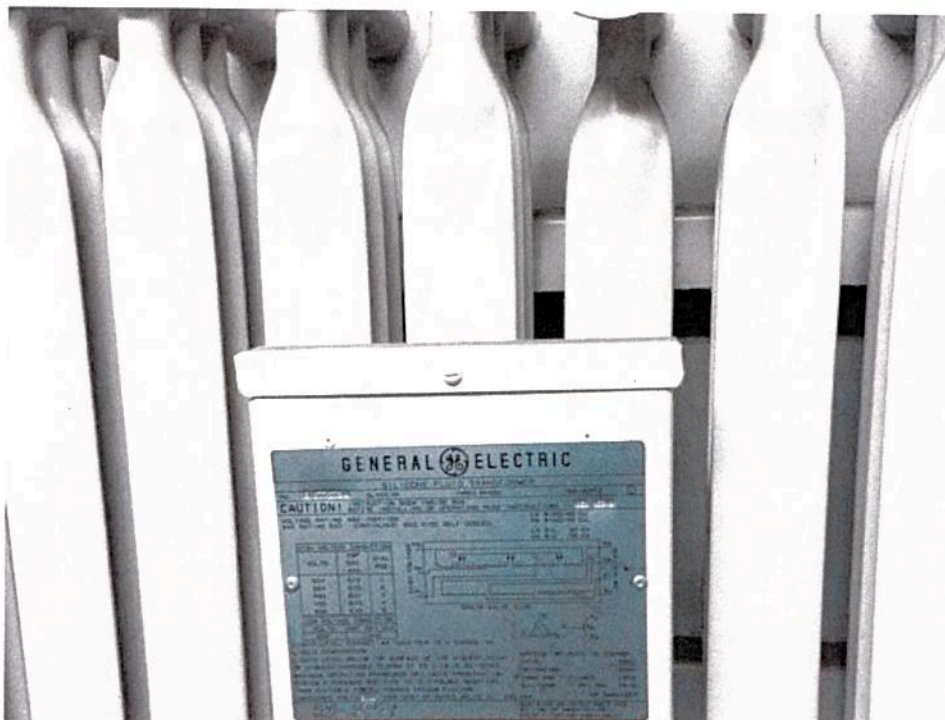
- The series of electrical transformers discovered in the basement level of the main building along the western edge of its interior represent a de minimis condition. Though the manufacturer’s plate on the transformer series suggests the dielectric fluid used in the machines is silicone, PCBs may have been historically used in its place.

Photograph 9: The manufacturer's plate on the transformers lining the interior western wall in the basement of the main building

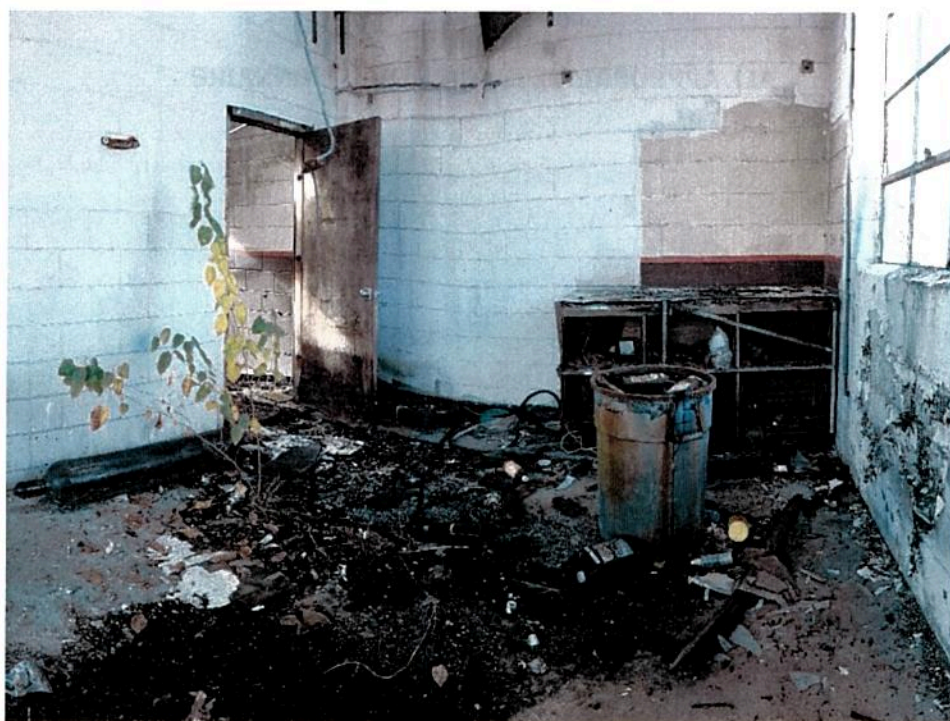
- The former fueling station was found to have multiple large (up to a few feet in diameter) holes in its ceiling, shallow pools of standing water, vegetative overgrowth, various industrial debris including small (less than 5-liter) chemical containers and plywood, and a floor drain in the bay portion of the station.

- The former fueling station was found to have multiple large (up to a few feet in diameter) holes in its ceiling and water damage associated with that structural deficiency. The potential for mold accumulation is likely.

Photograph 10: Inside the bay of the former gas station
